**Flood Control Project Maintenance
Levee Inspections**

Maintenance Issue Types Only, Levee Inspection Report By Mile - Spring 2019

Reclamation District No. 1500 Sutter Basin

Waterway	Bank	Unit Miles	Inspection Start/End	Inspector
Unit No. 01 Sacramento River	Left	33.15	04/24/2019 04/26/2019	Zach Jojola

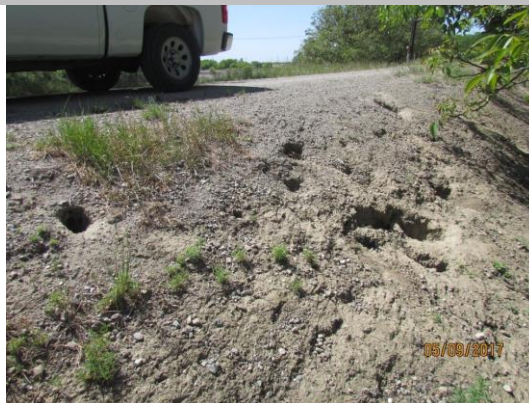
Photo 1 of 1 : SP_2019_RD1500_189_152_20190304_00079.jpg

View of rodent holes on landside slope. Spring 2017.

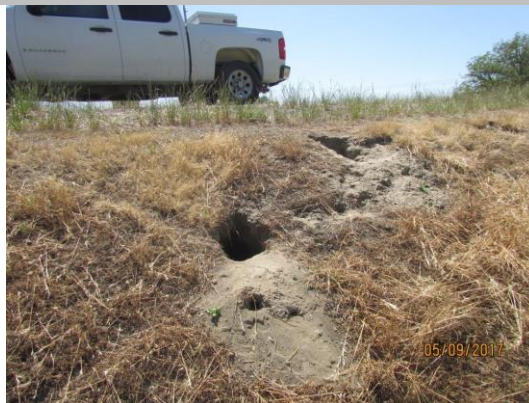
Photo 1 of 1 : SP_2019_RD1500_189_149_20190304_00078.jpg

View of rodent holes on landside slope. Spring 2017.

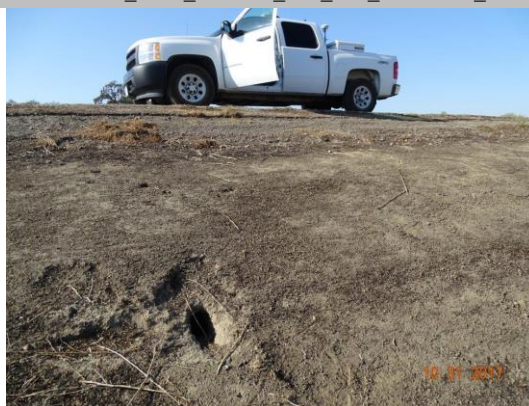
Photo 1 of 1 : SP_2019_RD1500_189_100_20190304_00049.jpg

View of hole on landside hope. Fall 2017.

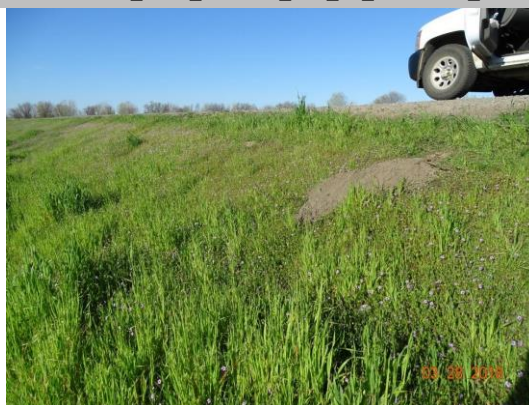
Photo 1 of 2 : SP_2019_RD1500_189_99_20190304_00047.jpg

LM Start	1.25	Rating **	M	Issue No.	99
LM End	1.25	Issue Type +	Ma	Location *	LS
Category	Earthen Levee			GPS Latitude/Longitude	
				Start	End
Item	Animal Control			38.769274 °	38.769274 °
				-121.691700 °	-121.691700 °
DWR ID	DWR_RD1500_01_f_2017_99				
Comment Code					
A3 : No rodents visible, but rodent burrows visible; need to backfill and compact or grout burrows.					
Inspector Comment					
There are multiple rodent holes and mounds on the landside slope.

View of rodent holes. Spring 2018

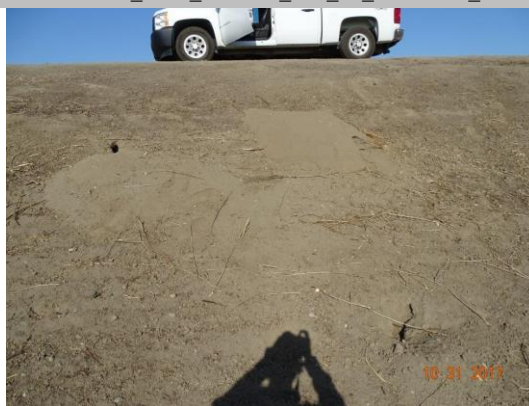
Photo 2 of 2 : SP_2019_RD1500_189_99_20190304_00048.jpg

View of holes and mounds on landside slope. Fall 2017.

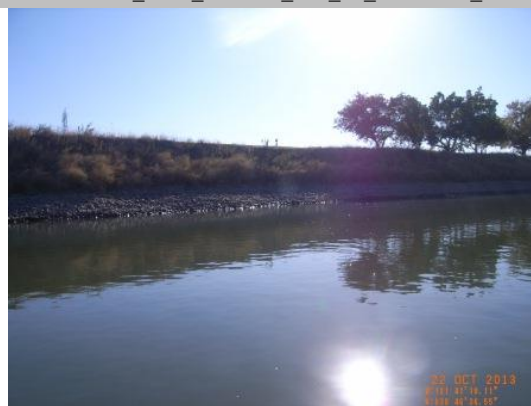
Photo 1 of 1 : SP_2019_RD1500_189_85_20190304_00037.jpg

LM Start	1.34	Rating **	A/W	Issue No.	85
LM End	1.95	Issue Type +	Ma	Location *	WS
Category	Supplemental			GPS Latitude/Longitude	
				Start	End
Item	2017 USACE Erosion Survey, DRAFT			38.770390 °	38.777282 °
				-121.690553 °	-121.685841 °
DWR ID	DWR_RD1500_01_f_2018_85				
Comment Code					
Inspector Comment					
2017 Site ID: SAC 86.3 L Status: Eroding 2017 Field Notes: No observed change.. Site History: 2006 - New erosion upstream, new bank failures near levee but still fairly wide berm in most places. 2008 - Large berm, questionable as to if it should remain in the inventory. 2010 - Minor new erosion, old cobble starting to fail. 2011 - Cobble continues to unravel and additional slumping. 2012 - Minor new erosion at bank mid point. 2013 - Minor new erosion. 2016 - Toe relatively stable. Upper slope is over steepened.

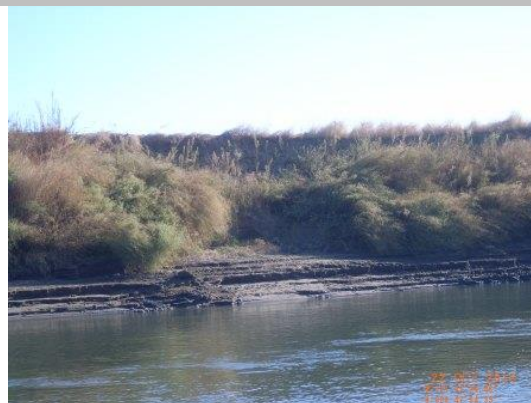
Photo 1 of 1 : SP_2019_RD1500_189_87_20190304_00040.jpg

LM Start	2.30	Rating **	A/W	Issue No.	87
LM End	2.52	Issue Type +	Ma	Location *	WS
Category	Supplemental			GPS Latitude/Longitude	
				Start	End
Item	2017 USACE Erosion Survey, DRAFT			38.781962 °	38.784936 °
				-121.688033 °	-121.690033 °
DWR ID	DWR_RD1500_01_f_2018_87				
Comment Code					
Inspector Comment					
2017 Site ID: SAC 87.1 L					
Status: Eroding					
2017 Field Notes: Large whole bank failure section in middle of site.					
Site History: 2010 - The upstream end of the repair site at 87.0. Repair did not extend far enough upstream. 2011 - New erosion pockets.					
2012 - Minor new erosion at toe. 2013 - Minor new erosion. 2015 - Significant new toe erosion. 2016 - Fresh erosion on riverbank.

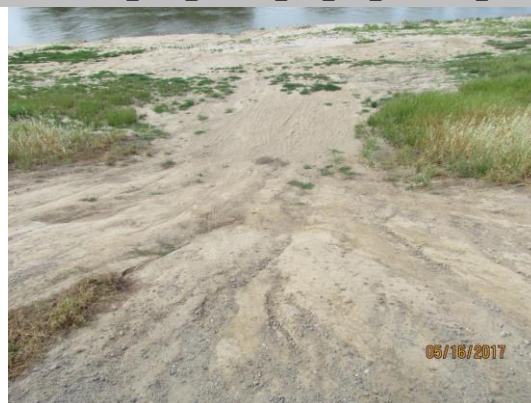
Photo 1 of 1 : SP_2019_RD1500_189_162_20190304_00080.jpg

LM Start	9.71	Rating **	A/W	Issue No.	162
LM End	9.71	Issue Type +	Ma	Location *	WS
Category	Earthen Levee			GPS Latitude/Longitude	
				Start	End
Item	Slope Stability			38.853564 °	38.853564 °
				-121.725379 °	-121.725379 °
DWR ID	DWR_RD1500_01_s_2017_162				
Comment Code					
S3 : Repair the levee slope damaged by vehicle traffic and prevent access where possible.					
Inspector Comment					
The area is heavily accessed by trailer residents and fishermen. Recommend monitoring.

View of slope stability on waterside slope. Spring 2017.

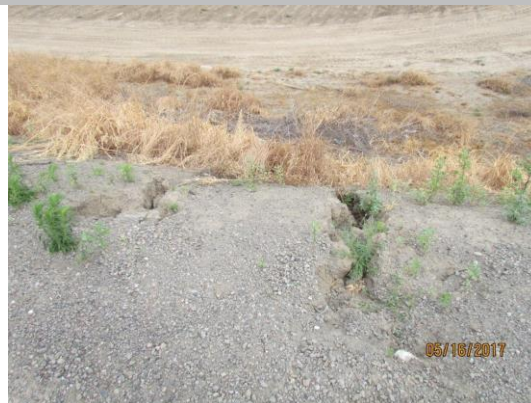
Photo 1 of 1 : SP_2019_RD1500_189_116_20190304_00058.jpg

LM Start	12.01	Rating **	M	Issue No.	116
LM End	12.01	Issue Type +	Ma	Location *	LS
Category	Earthen Levee			GPS Latitude/Longitude	
				Start	End
Item	Erosion / Bank Caving			38.870730 °	38.870730 °
				-121.752908 °	-121.752908 °
DWR ID	DWR_RD1500_01_s_2017_116				
Comment Code					
E2 : Schedule repair of erosion site prior to the next inspection.					
Inspector Comment					
There is runoff erosion on the landside levee slope.

View of erosion on landside slope. Spring 2017.

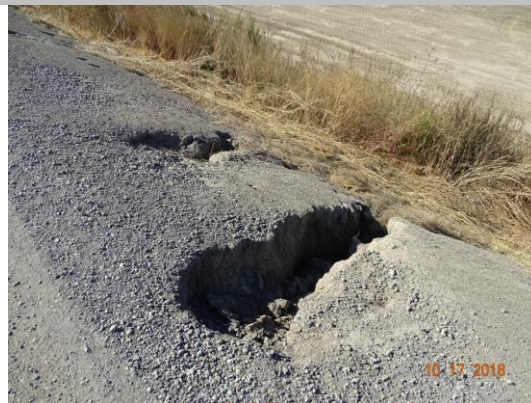
Photo 1 of 2 : SP_2019_RD1500_189_118_20190304_00060.jpg

LM Start	12.57	Rating **	U	Issue No.	118
LM End	12.57	Issue Type +	Ma	Location *	WS
Category	Earthen Levee			GPS Latitude/Longitude	
				Start	End
Item	Erosion / Bank Caving			38.867108 °	38.867108 °
				-121.761498 °	-121.761498 °
DWR ID	DWR_RD1500_01_f_2015_118				
Comment Code					
E2 : Schedule repair of erosion site prior to the next inspection.					
Inspector Comment					
Recommend backfilling erosion.

Updated view of erosion on the landside slope. Fall 2018.

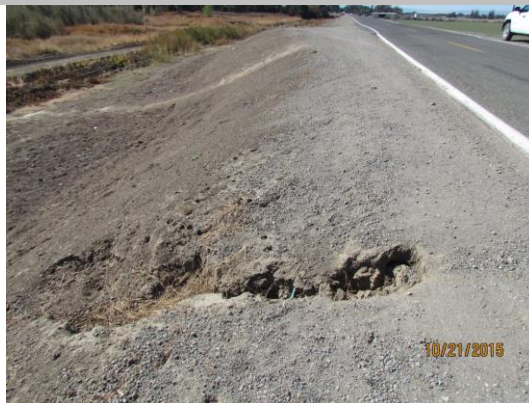
Photo 2 of 2 : SP_2019_RD1500_189_118_20190304_00061.jpg

LM Start	12.57	Rating **	U	Issue No.	118 (cont)	
LM End	12.57	Issue Type +	Ma	Location *	WS	
Category	Earthen Levee			GPS Latitude/Longitude		
				Start		End
Item	Erosion / Bank Caving			38.867108 °		38.867108 °
				-121.761498 °		-121.761498 °
DWR ID	DWR_RD1500_01_f_2015_118					
Comment Code						
E2 : Schedule repair of erosion site prior to the next inspection.						
Inspector Comment						
Recommend backfilling erosion.

View of the erosion on the waterward side of the levee looking upstream.
Fall 2015.

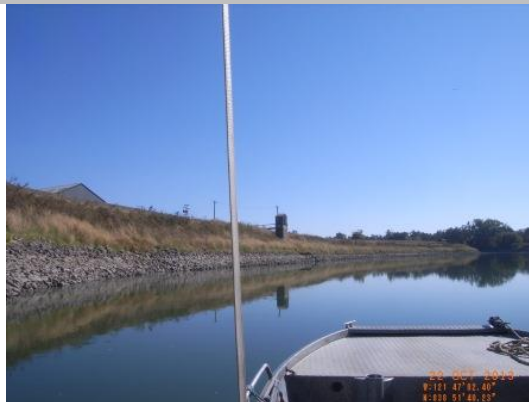
Photo 1 of 1 : SP_2019_RD1500_189_89_20190304_00041.jpg

LM Start	13.98	Rating **	A/W	Issue No.	89
LM End	14.28	Issue Type +	Ma	Location *	WS
Category	Supplemental			GPS Latitude/Longitude	
				Start	End
Item	2017 USACE Erosion Survey, DRAFT			38.857239 °	38.861899 °
				-121.783771 °	-121.784057 °
DWR ID	DWR_RD1500_01_f_2018_89				
Comment Code					
Inspector Comment					
2017 Site ID: SAC 99.0 L					
Status: Eroding					
2017 Field Notes: Rock continues to unravel.					
Site History: 1997 - Intermittent toe failure of the hand placed riprap;					
failure of toe materials.

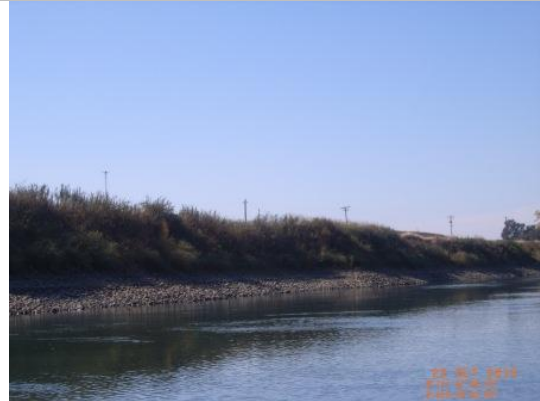
Photo 1 of 1 : SP_2019_RD1500_189_80_20190304_00031.jpg

LM Start	18.38	Rating **	A/W	Issue No.	80
LM End	19.06	Issue Type +	Ma	Location *	WS
Category	Supplemental			GPS Latitude/Longitude	
				Start	End
Item	2017 USACE Erosion Survey, DRAFT			38.901337 °	38.902721 °
				-121.801175 °	-121.790677 °
DWR ID	DWR_RD1500_01_f _ 2018_80				
Comment Code					
Inspector Comment					
2017 Site ID: SAC 104.0 L					
Status: Eroding					
2017 Field Notes: Bank slope is relatively stable.					
Site History: 1997 - Pocket failures of cobble revetment toe; scallops of rock loss along the bank; irregular bankline developing. 2001 - Small scallops in the toe of the berm. 2005 - Still multiple erosion pockets in the toe. 2006 - Two new small slumps. 2011 - Old cobble continue to fail causing minor slumping. 2012 - Portions of site appears to be stabilizing. 2016- Cobble revetment continues to fail.

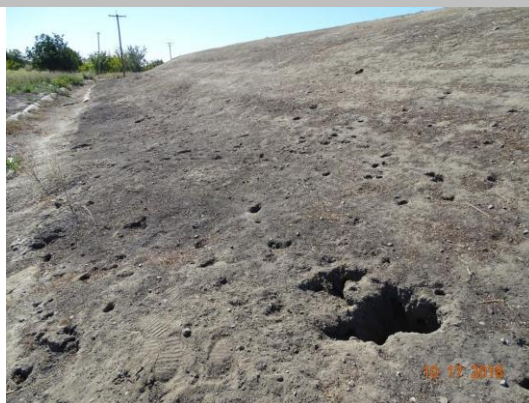
Photo 1 of 1 : SP_2019_RD1500_189_103_20190304_00050.jpg

View of rodent holes on the landside slope. Fall 2018.

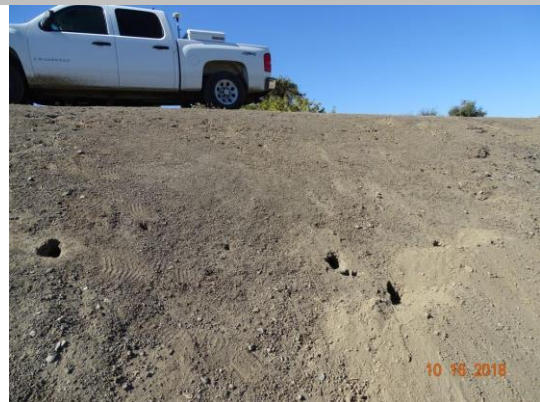
Photo 1 of 1 : SP_2019_RD1500_189_95_20190304_00044.jpg

View of rodent holes on the landside slope. Fall 2018.

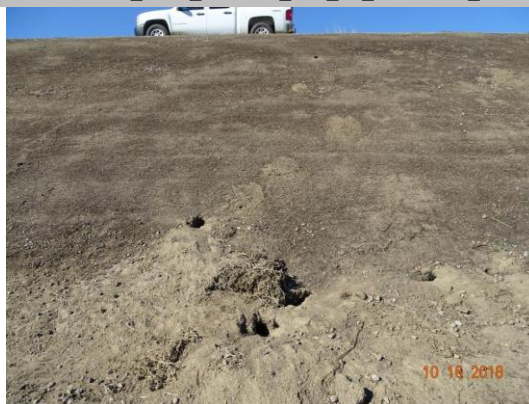
Photo 1 of 1 : SP_2019_RD1500_189_92_20190304_00042.jpg

View of rodent holes on the landside slope. Fall 2018.

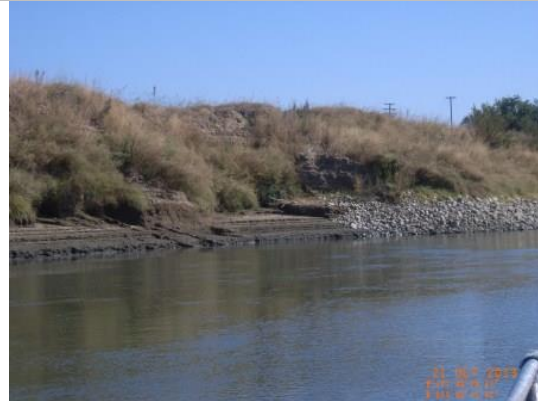
Photo 1 of 1 : SP_2019_RD1500_189_83_20190304_00034.jpg

Comment Code					
Inspector Comment					
2017 Site ID: SAC 116.5 L					
Status: Eroding					
2017 Field Notes: pipe and pump encroachment. site has been stable for a few years.					
Site History: 2003 - New sedimentation and some new small toe scallops at the upstream end; downstream end has some new erosion. 2004 - Some new erosion at the toe and upper bank and some small new rotational failures (mainly minor, except at the downstream end). 2007 - Some new slumps. 2009 - Some new scallops and site was extended upstream. 2010 - New deposition along upstream end of site, however there is also new erosion throughout the site. Site seems to be worsening, and eroding fast. Large habitat for bank swallows. 2011 - Some new minor erosion. 2012 - Minor new erosion. 2016 - Fresh erosion on lower bank.

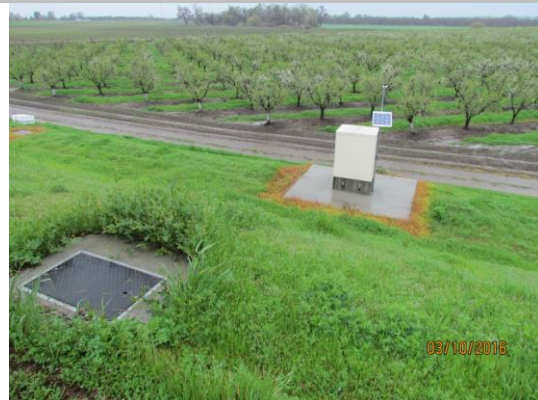
Photo 1 of 2 : SP_2019_RD1500_189_86_20190304_00038.jpg

LM Start	31.54	Rating **	A/W	Issue No.	86
LM End	31.54	Issue Type +	Ma	Location *	LS
Category	Earthen Levee			GPS Latitude/Longitude	
				Start	End
Item	Encroachments			39.006687 °	39.006687 °
				-121.814967 °	-121.814967 °
DWR ID	DWR_RD1500_01_s_2016_86				
Comment Code					
MW : Monitoring Well					
Inspector Comment					
UCIP installed this monitoring station for seepage in the area. Monitor for vandalism or damage PN: (18630).

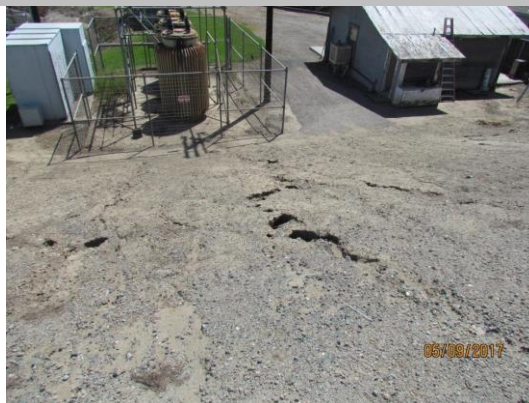
Photo 1 of 1 : SP_2019_RD1500_189_144_20190304_00077.jpg

LM Start	32.98	Rating **	M	Issue No.	144
LM End	32.98	Issue Type +	Ma	Location *	LS
Category	Earthen Levee			GPS Latitude/Longitude	
				Start	End
Item	Erosion / Bank Caving			39.020782 °	39.020782 °
				-121.820275 °	-121.820275 °
DWR ID	DWR_RD1500_01_s_2017_144				
Comment Code					
E2 : Schedule repair of erosion site prior to the next inspection.					
Inspector Comment					
There is runoff erosion on the landside slope.

View of erosion on landside slope. Spring 2017.

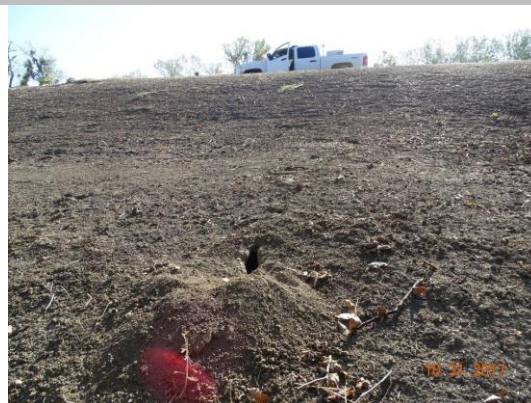
Photo 1 of 1 : SP_2019_RD1500_190_39_20190304_00011.jpg

View of rodent hole on landside slope. Fall 2017.

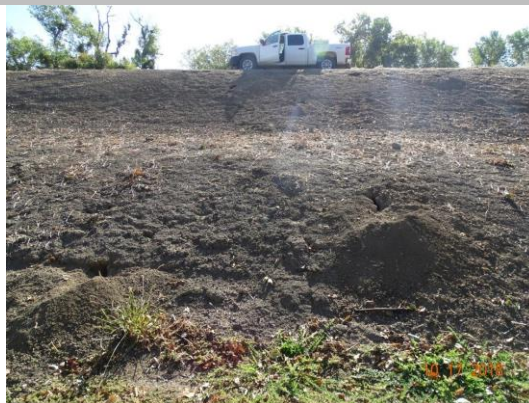
Photo 1 of 1 : SP_2019_RD1500_190_16_20190304_00009.jpg

View of rodent holes on the landside slope. Fall 2018.

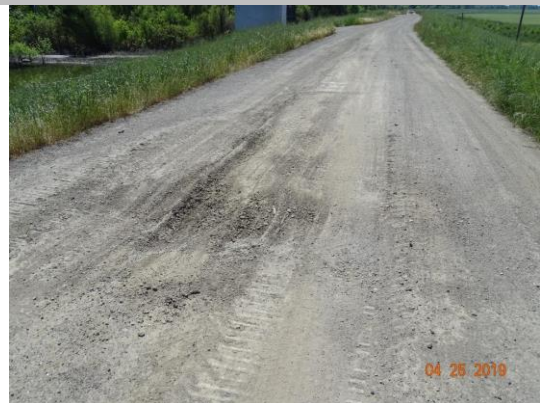
Photo 1 of 1 : SP_2019_RD1500_190_22_20190424_00042.jpg

View of rut on the crown. Spring 2019.

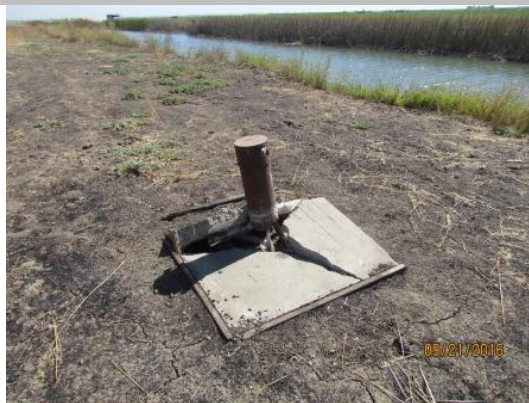
Photo 2 of 3 : SP_2019_RD1500_190_4_20190304_00002.jpg

Another view of damaged well. Fall 2016.
